South Sudan

Seasonal floods analysis in Maban county

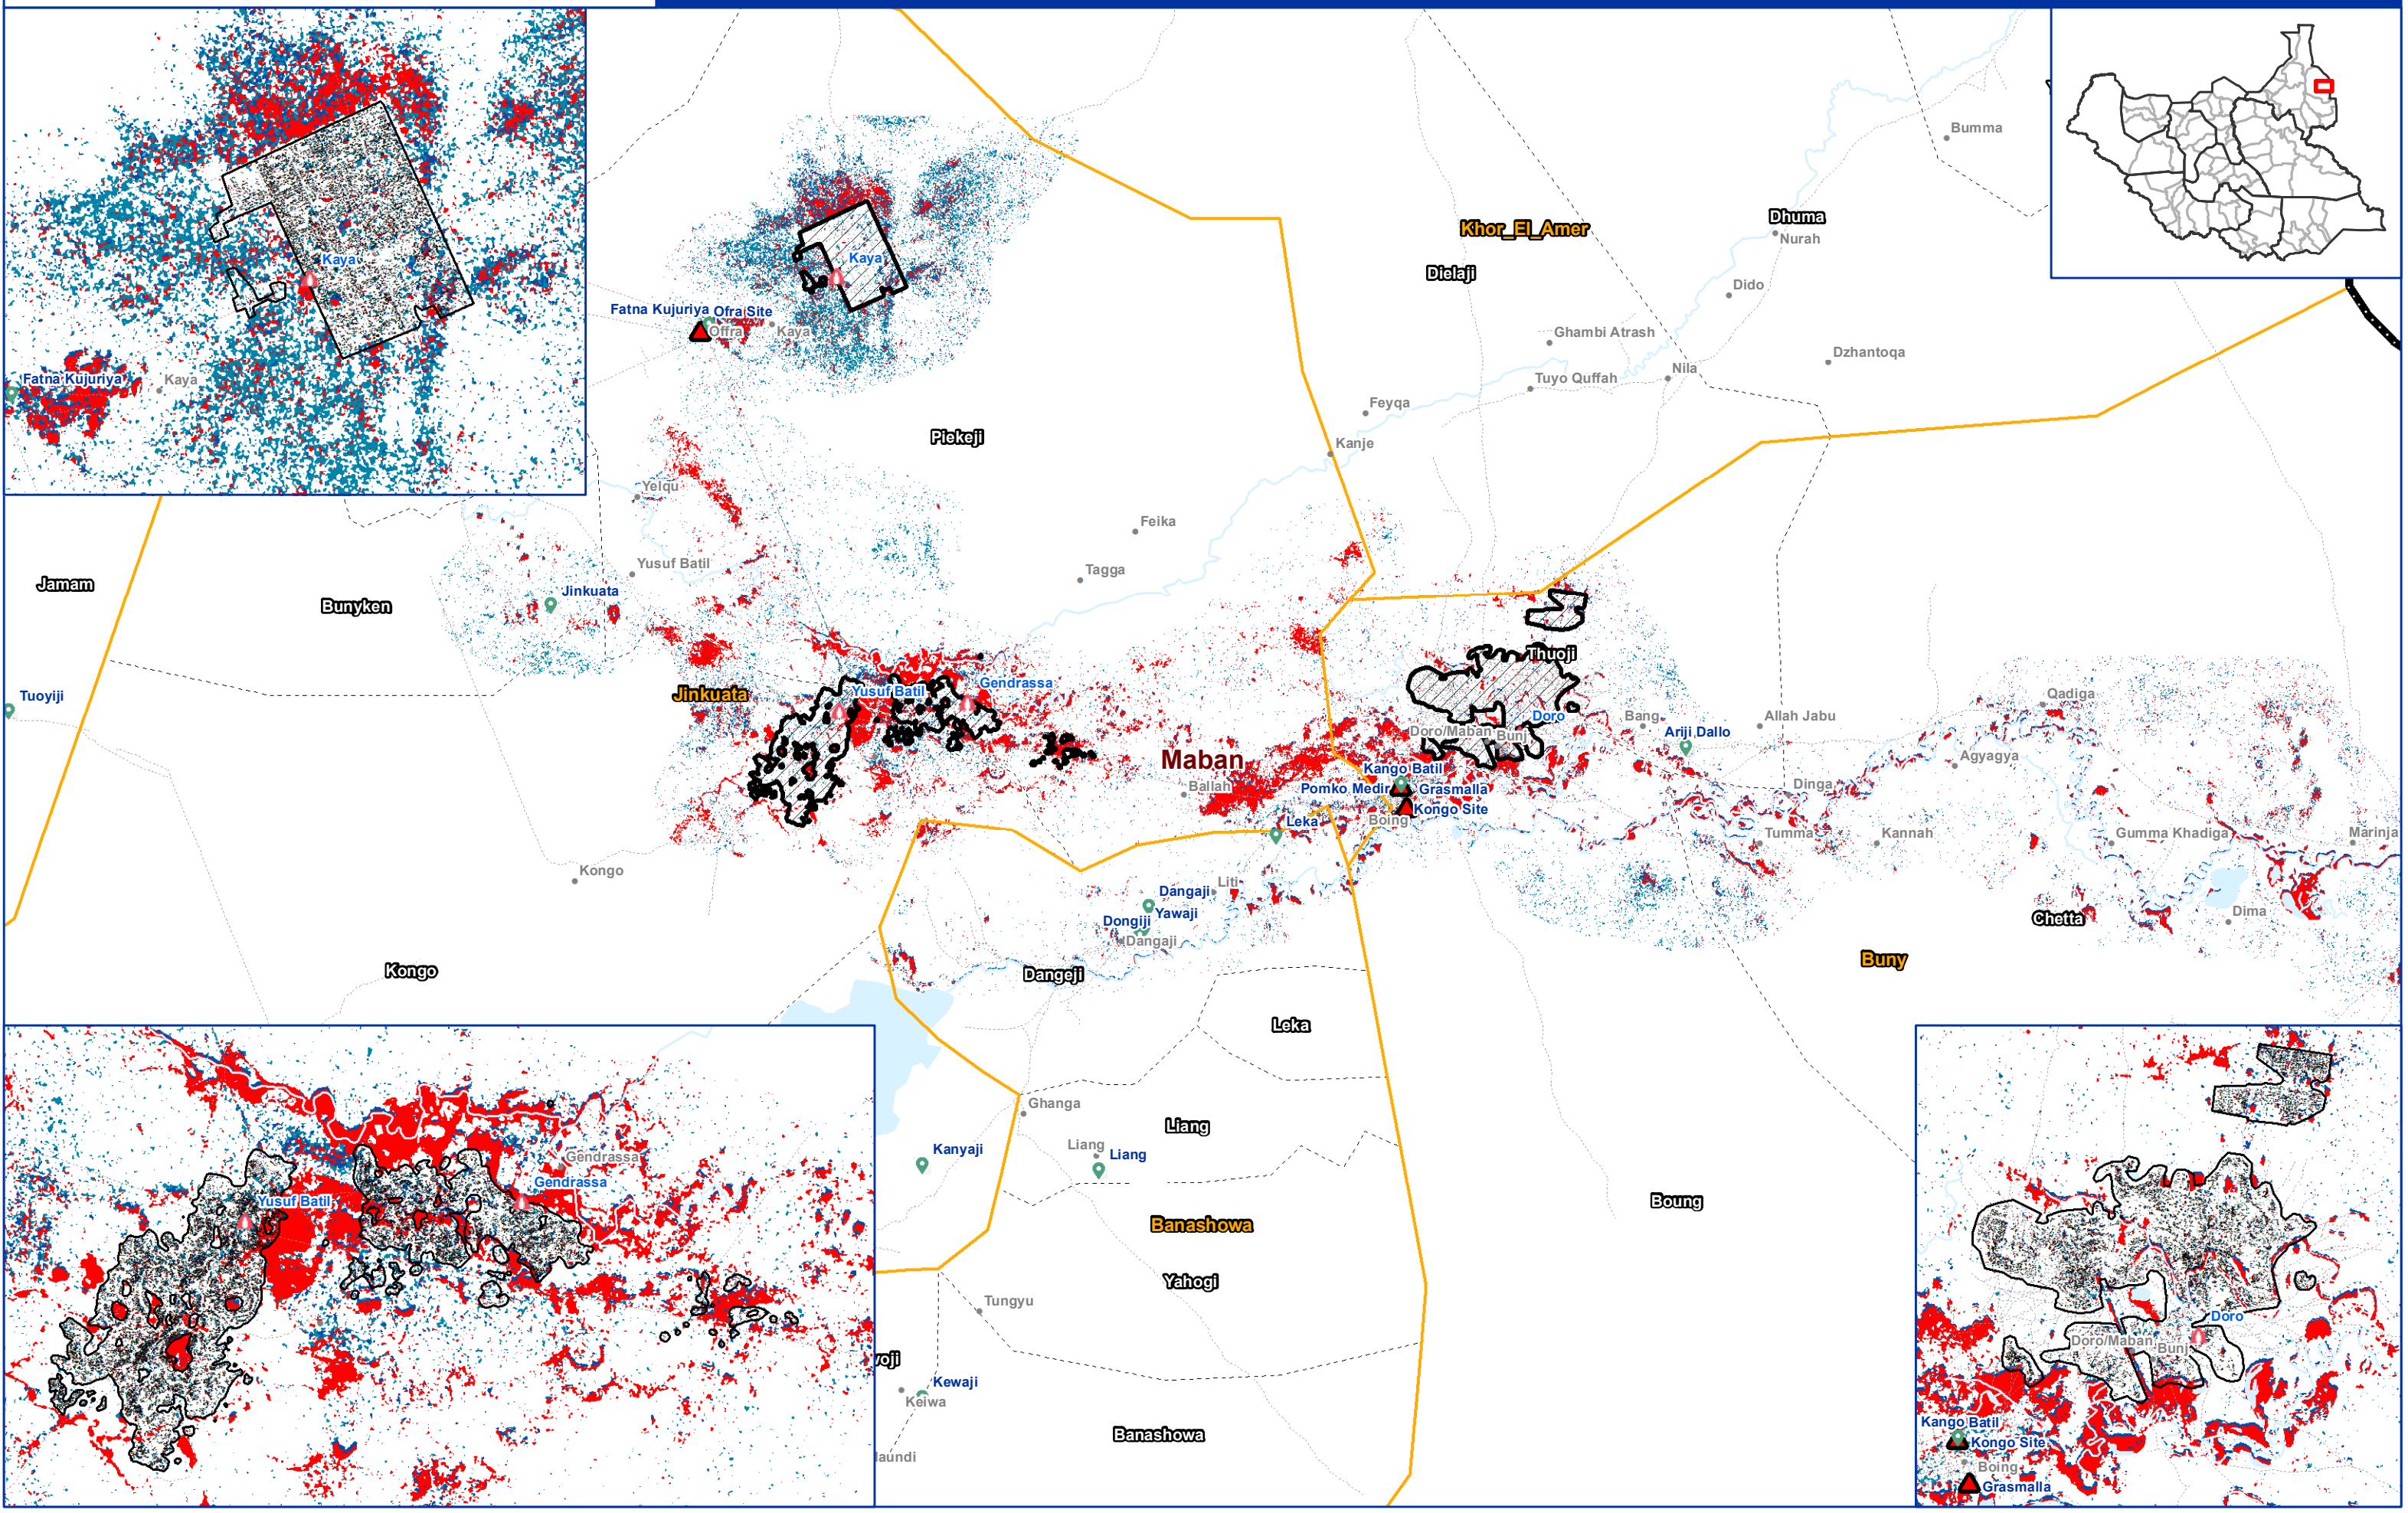
■ Detected water as of 18 October 2019
■ Detected water as of 12 October 2019
■ Detected water as of 06 October 2019

Map production date: 23 October 2019
 Main map scale at: 1:165,000
 Flood data analysis: IOM
 (Preliminary analysis. Need validation from the field.)
 Sensor: Sentinel-1 SAR (Synthetic Aperture Radar)
 Software: SNAP
 Sensor date: 06, 12, and 18 October 2019
 Camp extent and shelters data: UNOSAT
 Source data: IOM, OSM, UNHCR
